Satellite-Based Damage Assessment for Town of Baga, Borno State, Nigeria

(Assessment based on satellite imagery recorded on the mornings of April 6 and 26, 2013)

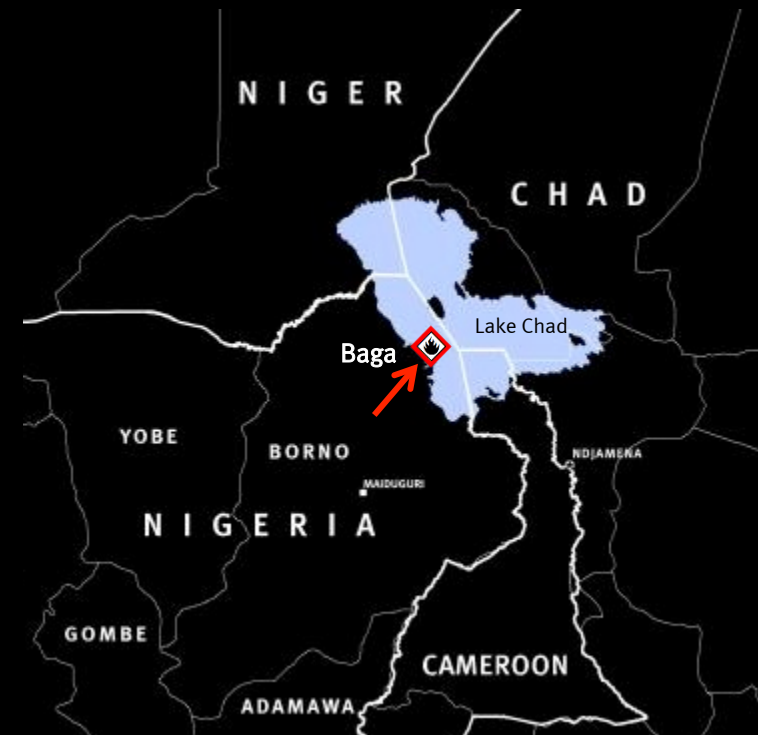
Baga - Overview of Building Damages as on April 26, 2013:

MAIN DAMAGE AREA: over 2,400 residential and commercial buildings likely destroyed and severely damaged within southern Baga.

The total area of damaged building and burnt vegetation cover measures over 80,000m² (8ha) in size.

Virtually all identified building damages exhibit signatures fully consistent with fire and correspond closely with areas of satellite-detected active fires on the night of April 16 and the afternoon of April 17, 2013

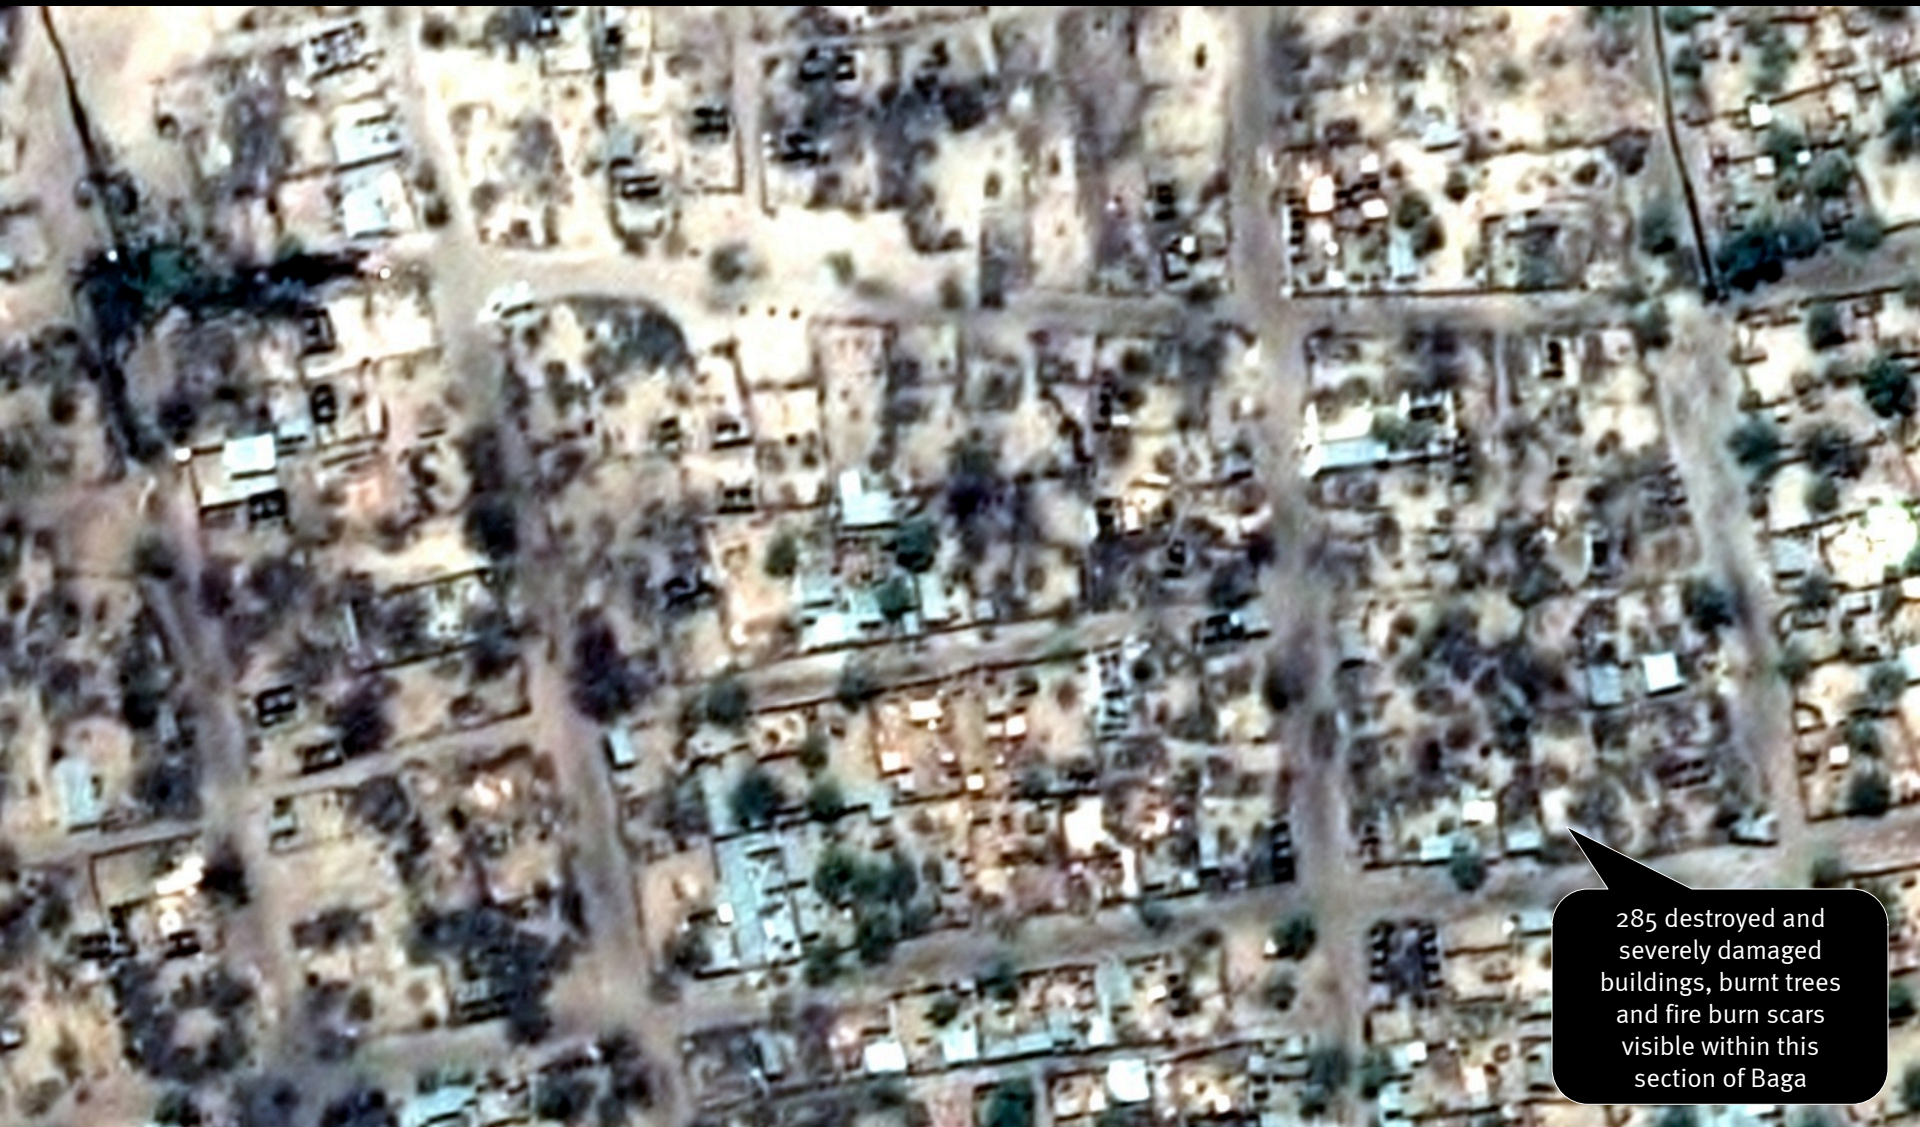
Baga – Focus Area 1 of Building Damages as on April 26, 2013: (Post-violence view of concentration of building damages)

285 destroyed and severely damaged buildings, burnt trees and fire burn scars visible within this section of Baga

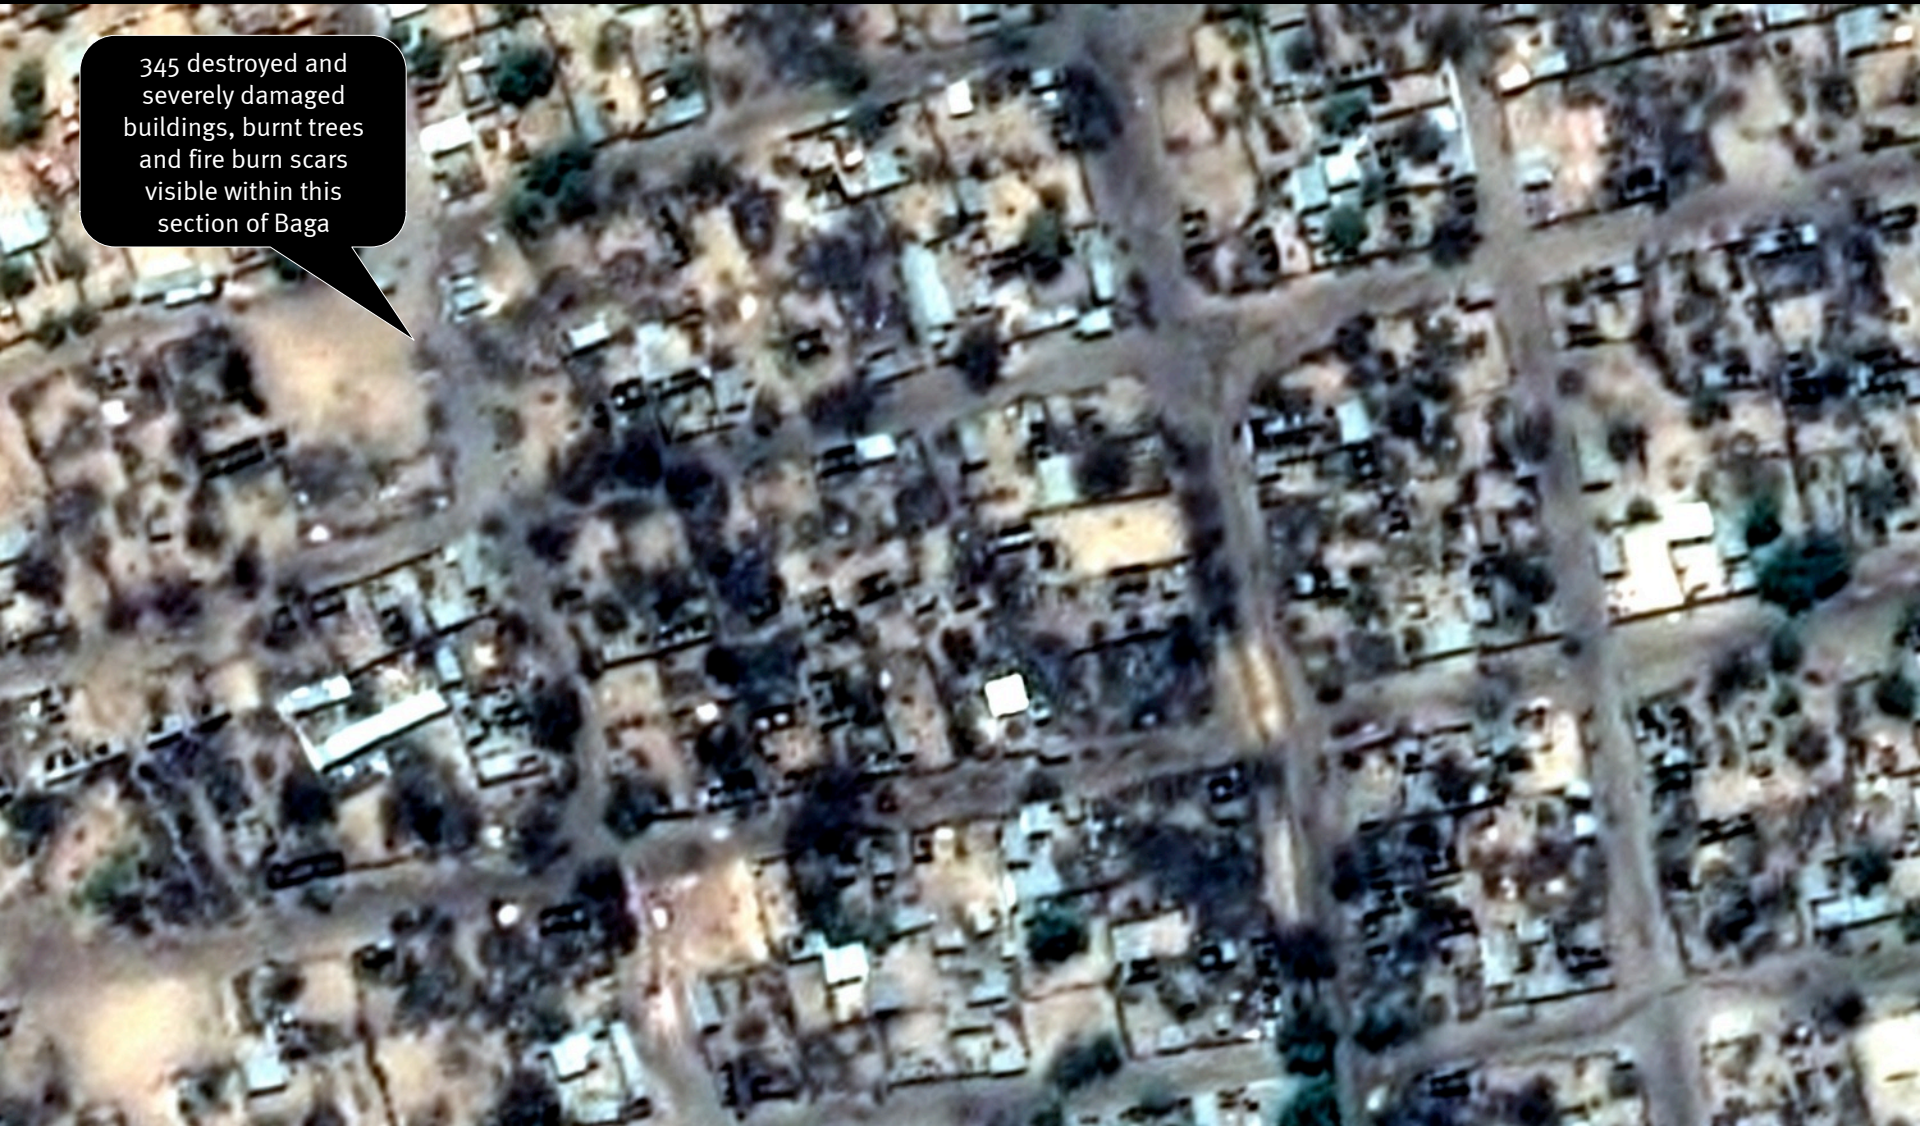
Baga – Focus Area 2 of Building Damages as on April 26, 2013: (Post-violence view of concentration of building damages)

345 destroyed and severely damaged buildings, burnt trees and fire burn scars visible within this section of Baga

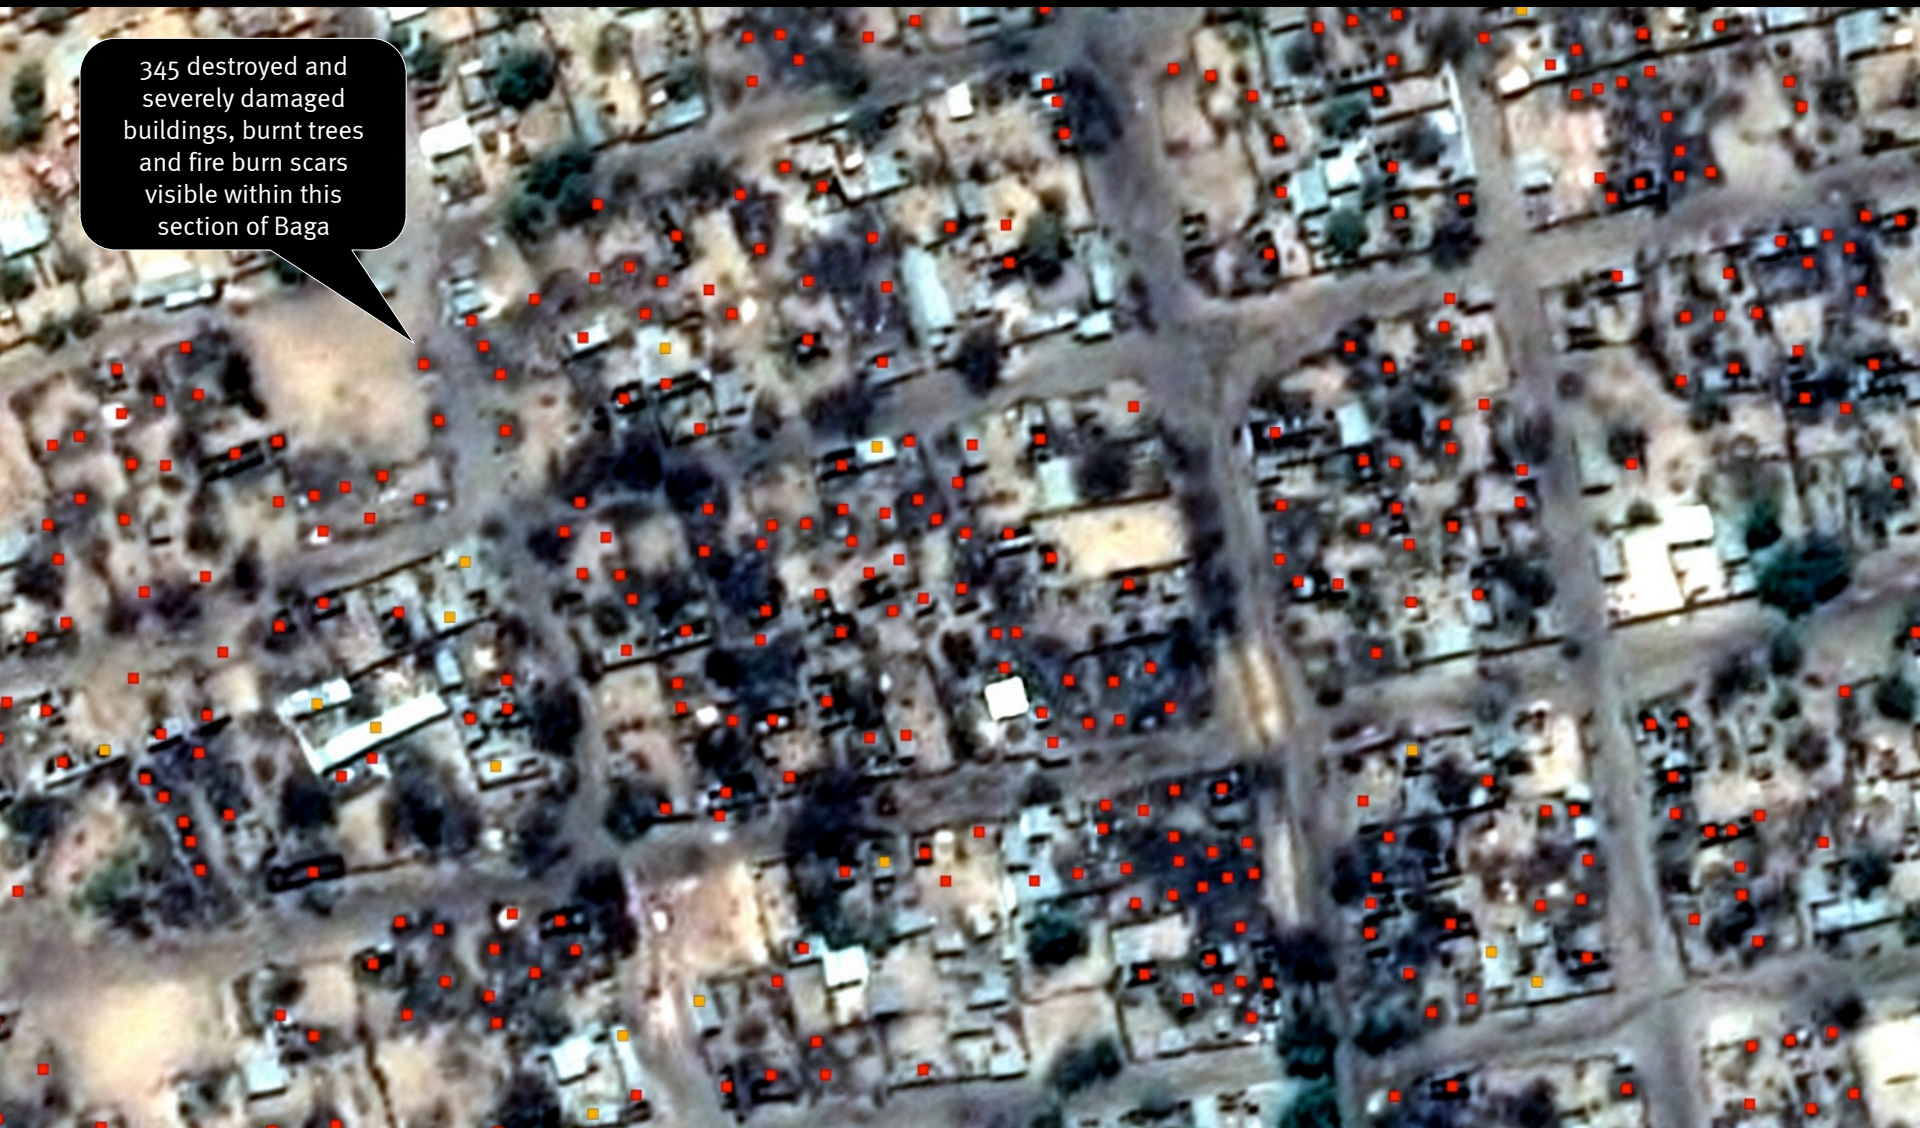
Baga – Focus Area 2 of Building Damages as on April 26, 2013: (Post-violence view of concentration of building damages– Damages Annotated)

345 destroyed and severely damaged buildings, burnt trees and fire burn scars visible within this section of Baga

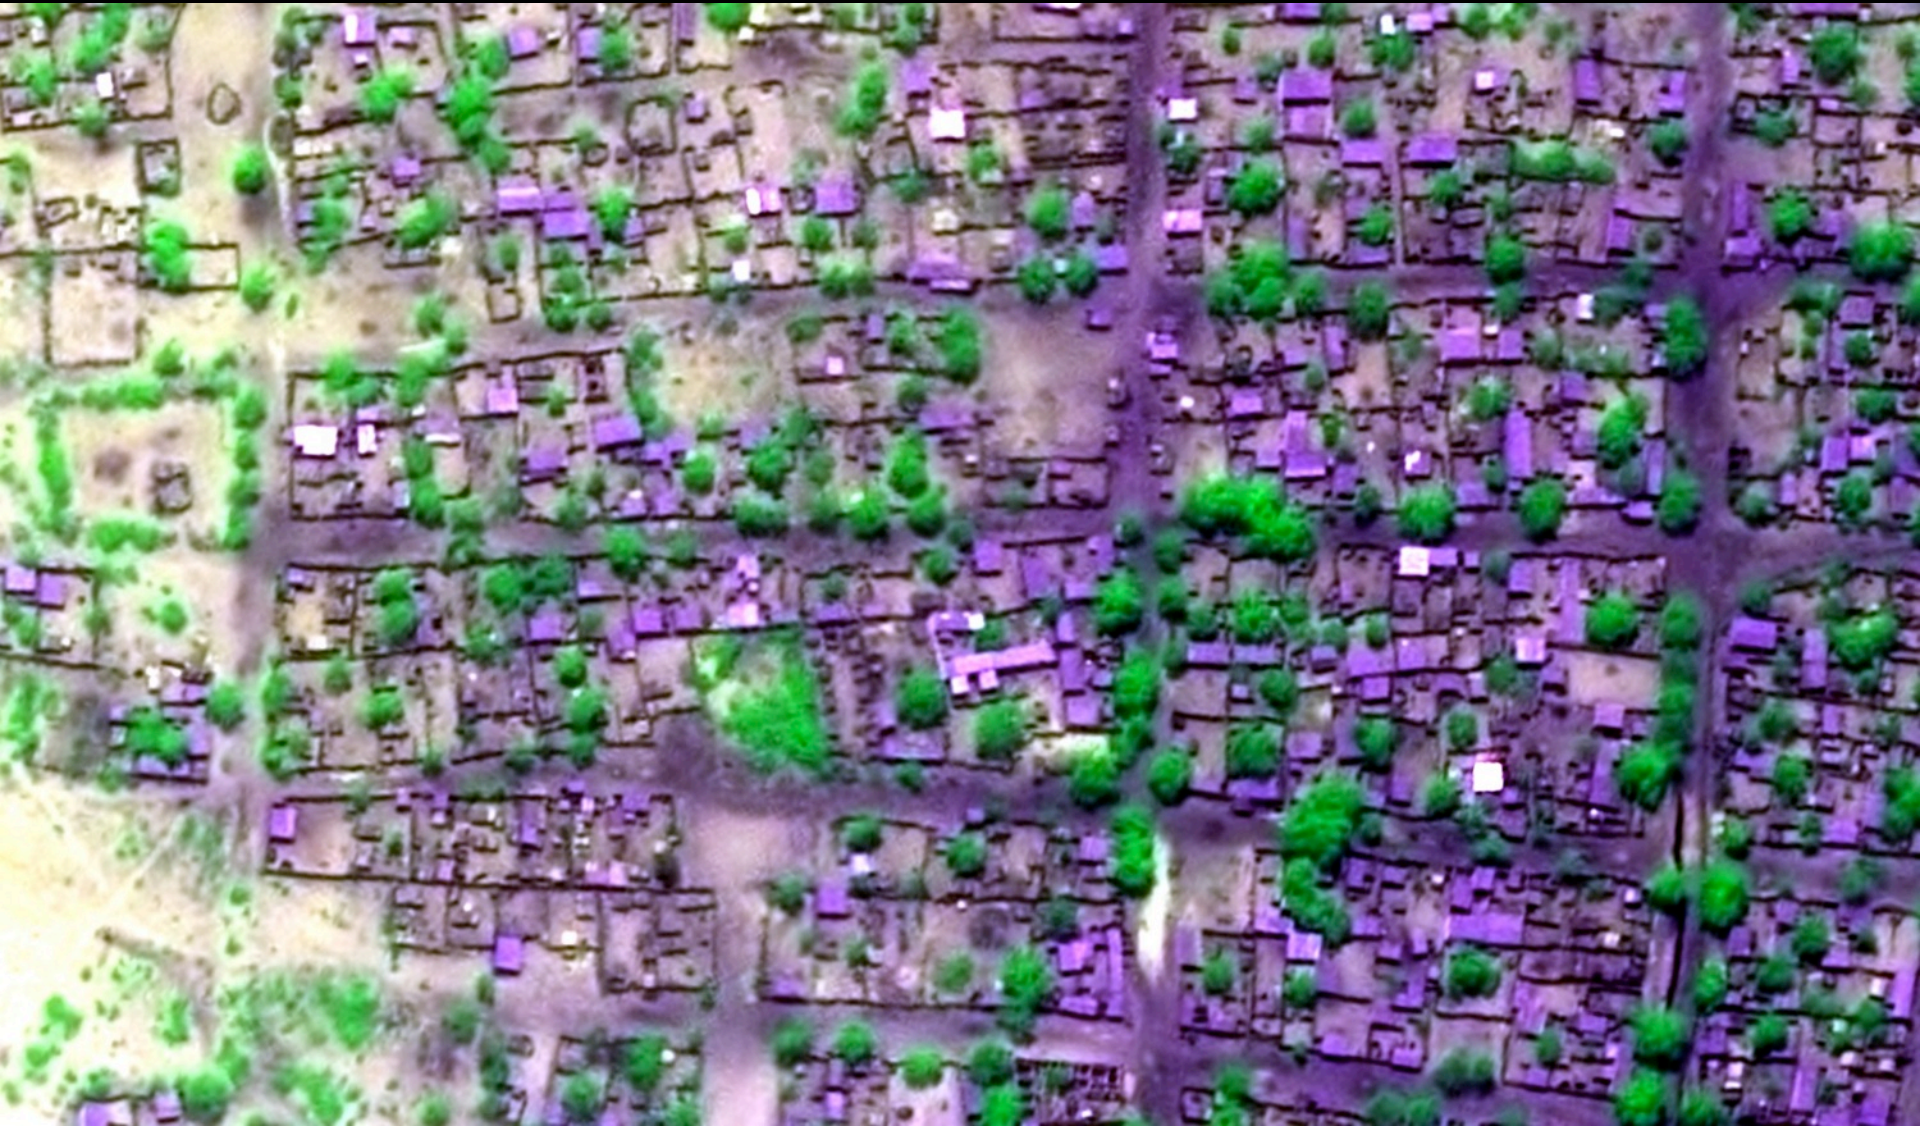
Baga – Focus Area 3 of Building Damages as on April 6, 2013:

(Pre-violence view of concentration of building damages, satellite imagery displayed in false-color, near-infrared to highlight areas of extensive fire-related damages and burn scars)

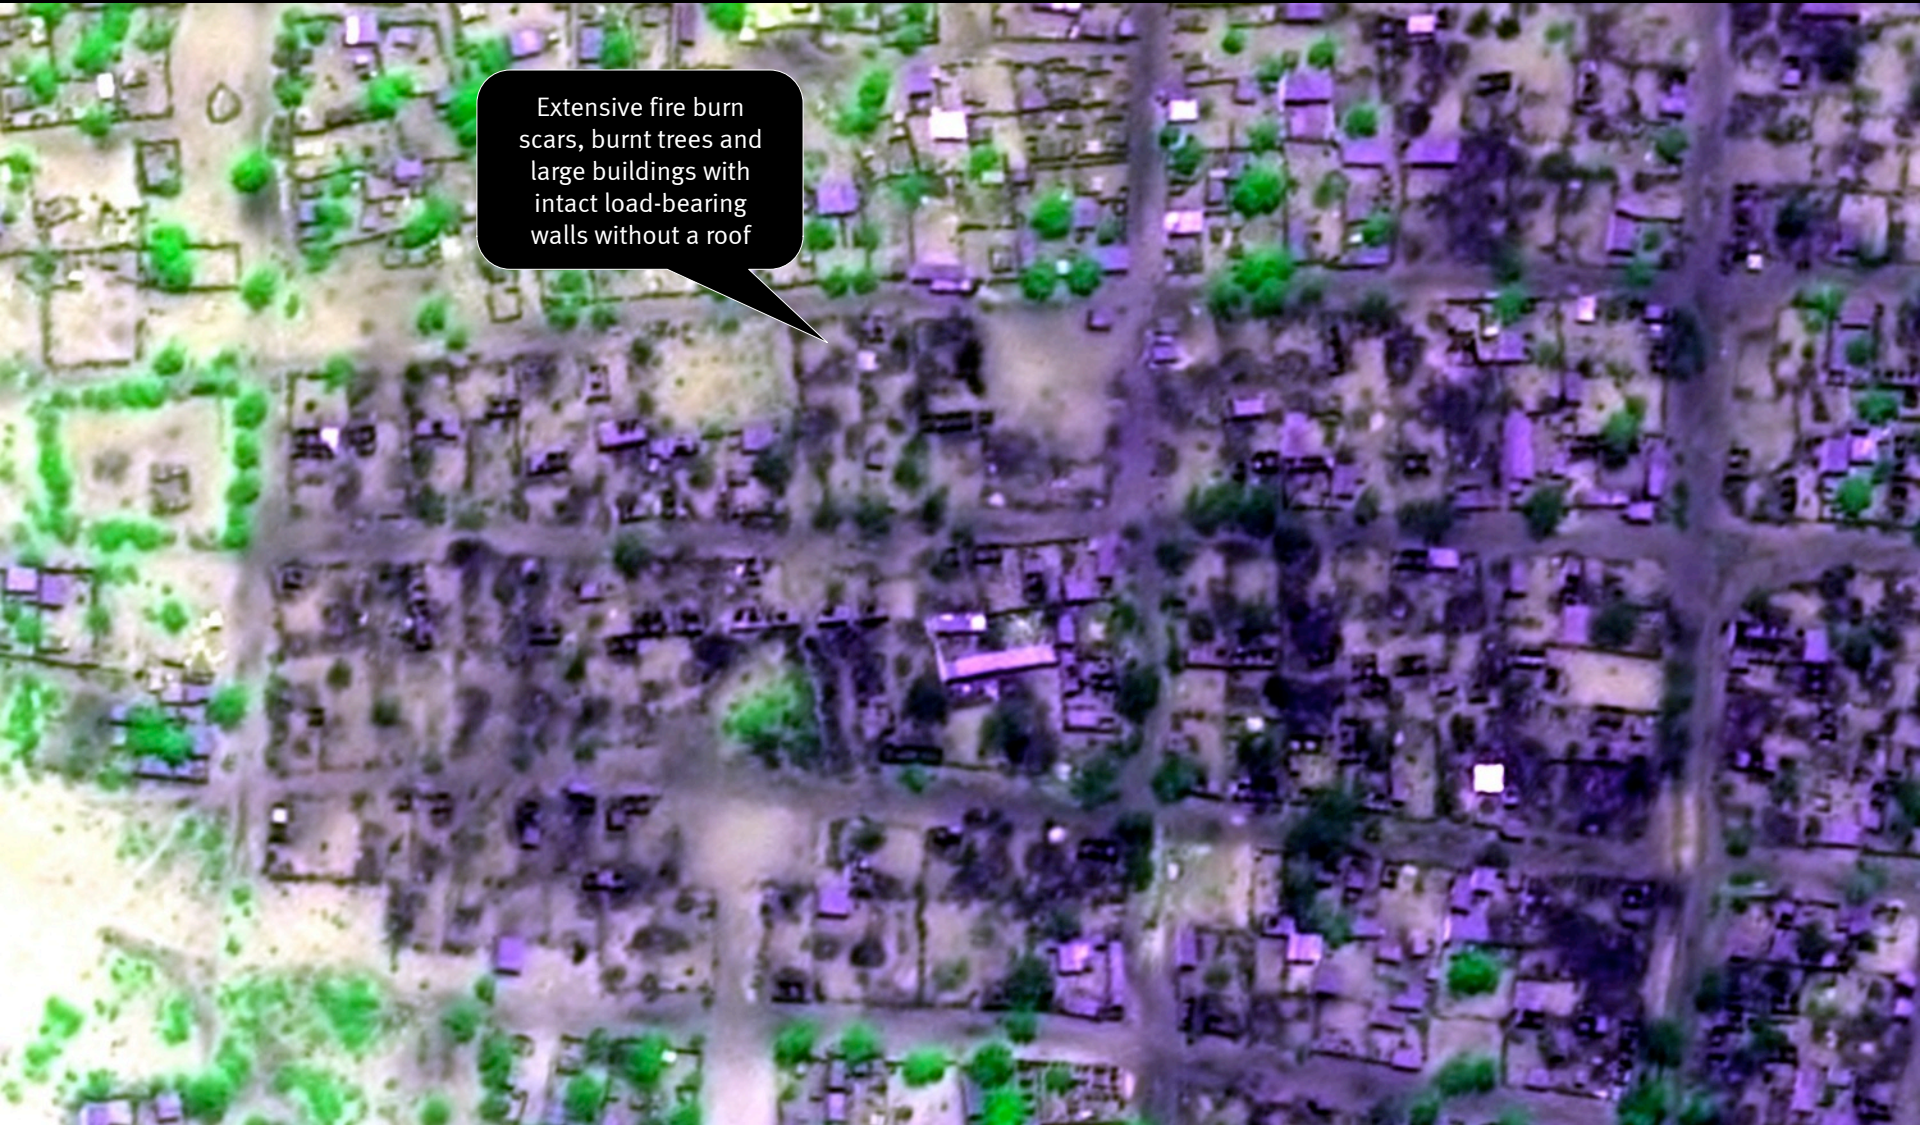
Baga – Focus Area 3 of Building Damages as on April 26, 2013:

(Post-violence view of concentration of building damages, satellite imagery displayed in false-color, near-infrared to highlight areas of extensive fire-related damages and burn scars)

Extensive fire burn scars, burnt trees and large buildings with intact load-bearing walls without a roof

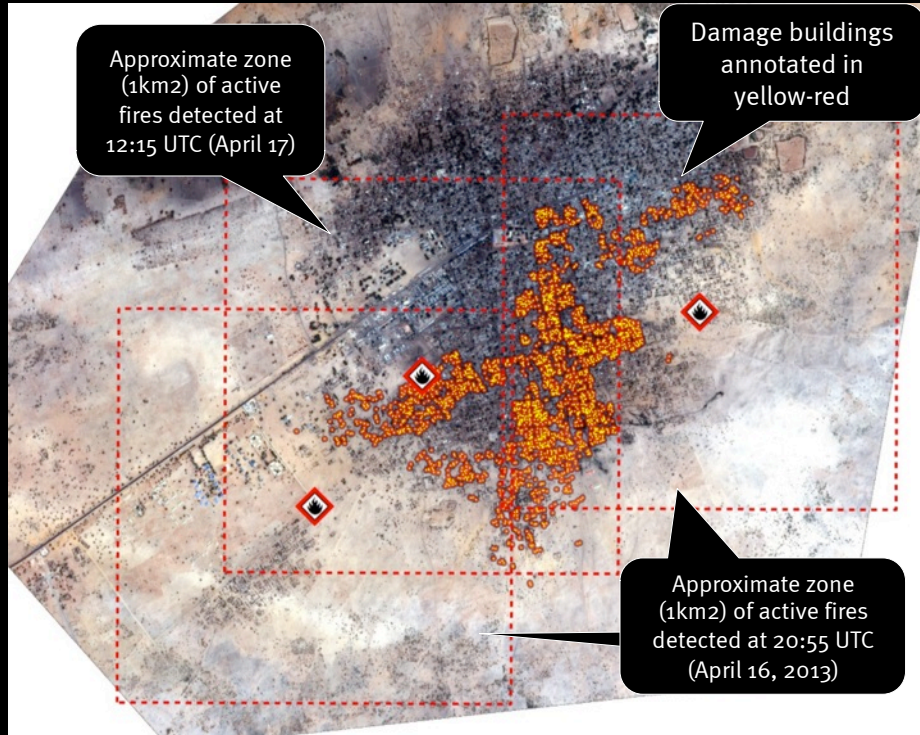
Review of Satellite-Detected Active Fires Detected over town of Baga on evening of April 16 and afternoon of April 17 2013:

(Active fires detected by NASA environmental satellite sensors: MODIS Aqua and Terra)

Satellite-detected active fires zones on April 16 and 17, 2013 closely match building damage locations.

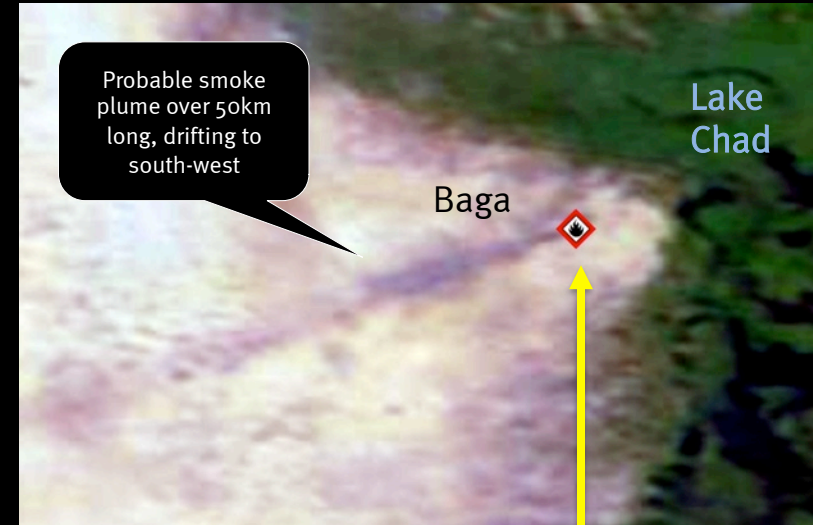
Active fire and associated smoke plume visible from Baga at 12:15 UTC April 17, 2013.
